AFFORDABLE SUSTAINABLE DESIGN
FOR A
RURAL HEAD START SCHOOL IN
DAYTON, OREGON

ABSTRACT

Head Start of Yamhill County, Oregon completed construction of a "super-insulated" energy efficient "green" Head Start facility in Dayton, Oregon. Head Start utilized innovative funding approaches and design techniques to work within federal and state program requirements. The monitored results indicate that the facility has achieved its stated goals of energy efficiency, high quality indoor environment, and lowered operational costs. Its lessons learned have been utilized in design and construction of its newest facility in Sheridan.

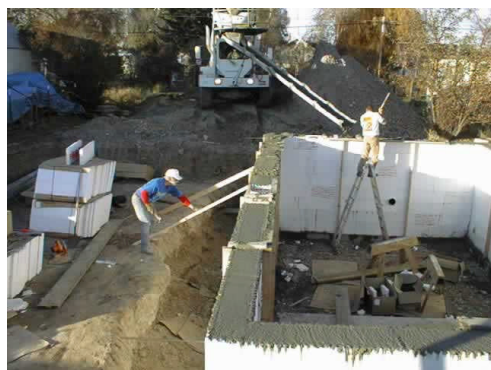
The long-axis of the building runs east and west with south glazing and roof overhangs to supplement and enhance the passive heating of the facility. Most of the windows are located on the south side and are classified as "super windows". The four-foot eave overhangs help keep the summer sun from over-heating the child development rooms.

Since the classrooms are for three- and four-year olds, the foot-deep south window sills are 10 inches off the floor. Therefore, there is a need for the floor and window areas to provide thermal comfort for the children.

A major contribution to the efficient heating of the facility is in the construction of the Dayton building. To optimize energy, the foundation is constructed from expanded polystyrene (EPS) insulating concrete forms (ICF's) for the footings and the walls, from the ground to the roof. The EPS, rated at R 10, was placed under the basement slab to disconnect the concrete from the ground, decrease thermal loss, and thereby completely encapsulating the building. The building's weight is borne by high density extruded polystyrene (XPS, 60 psi) insulation under the insulated footings. High density foam insulation (Poly-Form) was placed under the foundation footings completely isolating the concrete from the ground and thereby preventing thermal loss or fluctuations and decreasing moisture problems. This step decreases temperature fluctuations in the insulated concrete cores that could be created by changes in ground temperature. The footings and the walls are reinforced concrete contained in the ICF's. Three inches of EPS is added to the outside of the ICF's in order to increase the R value of the ICF resulting in a total R value of R30. An additional layer of exterior insulation brings the R value to R 42. By encapsulating the concrete in the ICF, the beneficial thermal mass effect of the concrete is heated by internal air. The concrete retains the heat and reduces fluctuations in indoor air temperature (ΔT). The only vapor barrier used is located below the basement slab.

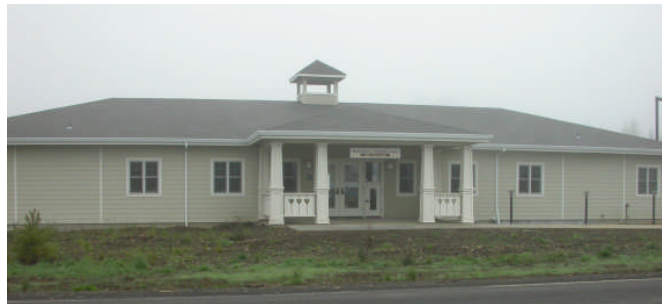
With the success of the Dayton facility, Head Start completed construction of its Sheridan facility in 2004. The building was sized at 4000 square feet compared to Dayton's 3500 square feet, and modifications were made to its HVAC system as well as its conditioned crawl space. Monitoring
